NWHC REPORT 7808  
22 NOVEMBER 1977

### TEST AND EVALUATION OF UNIT LOAD SKIDDED FOR ARMY 155 MM PROJECTILES

This report details the test and evaluation of an improved version of the Army's 18 Round 155MM Projectile Skidded Unit Load. Test results indicate that the unit load is suitable for its intended purpose.

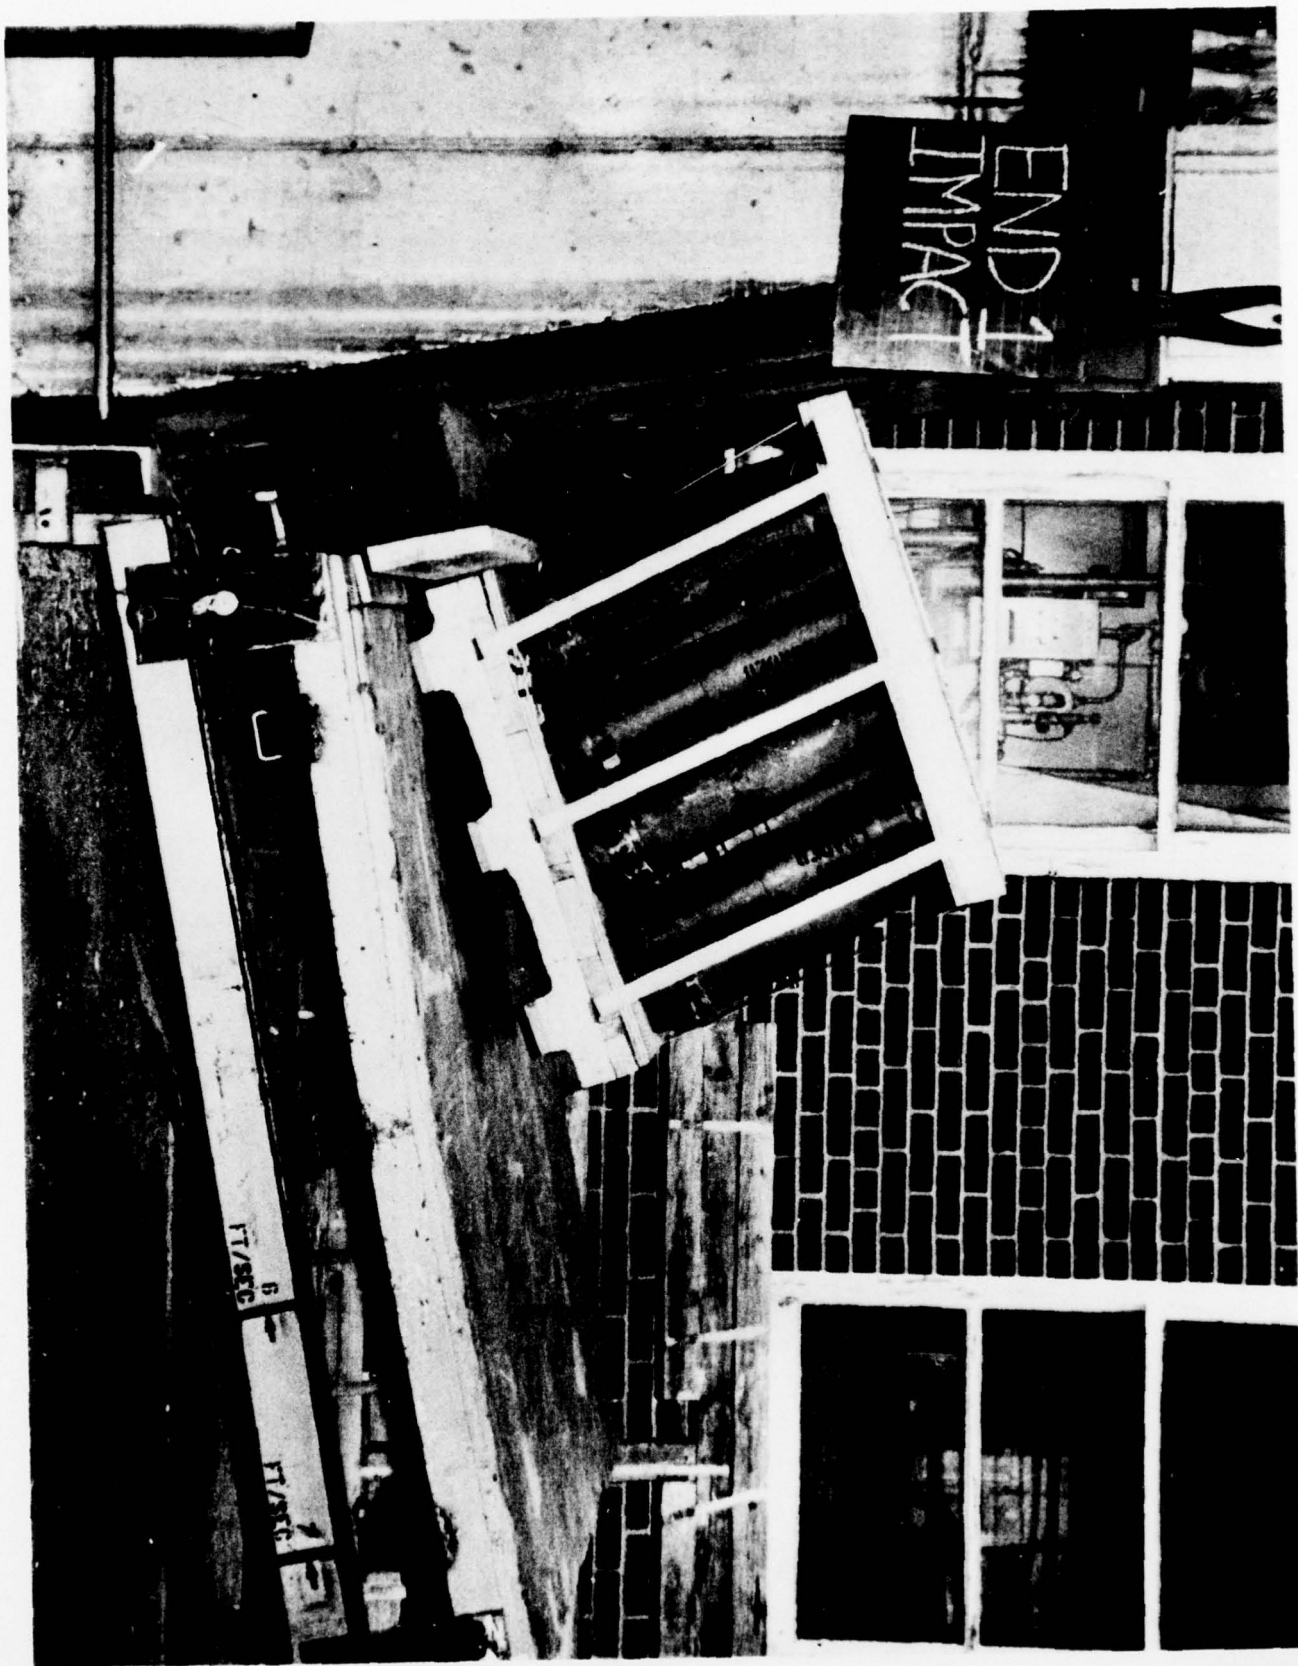
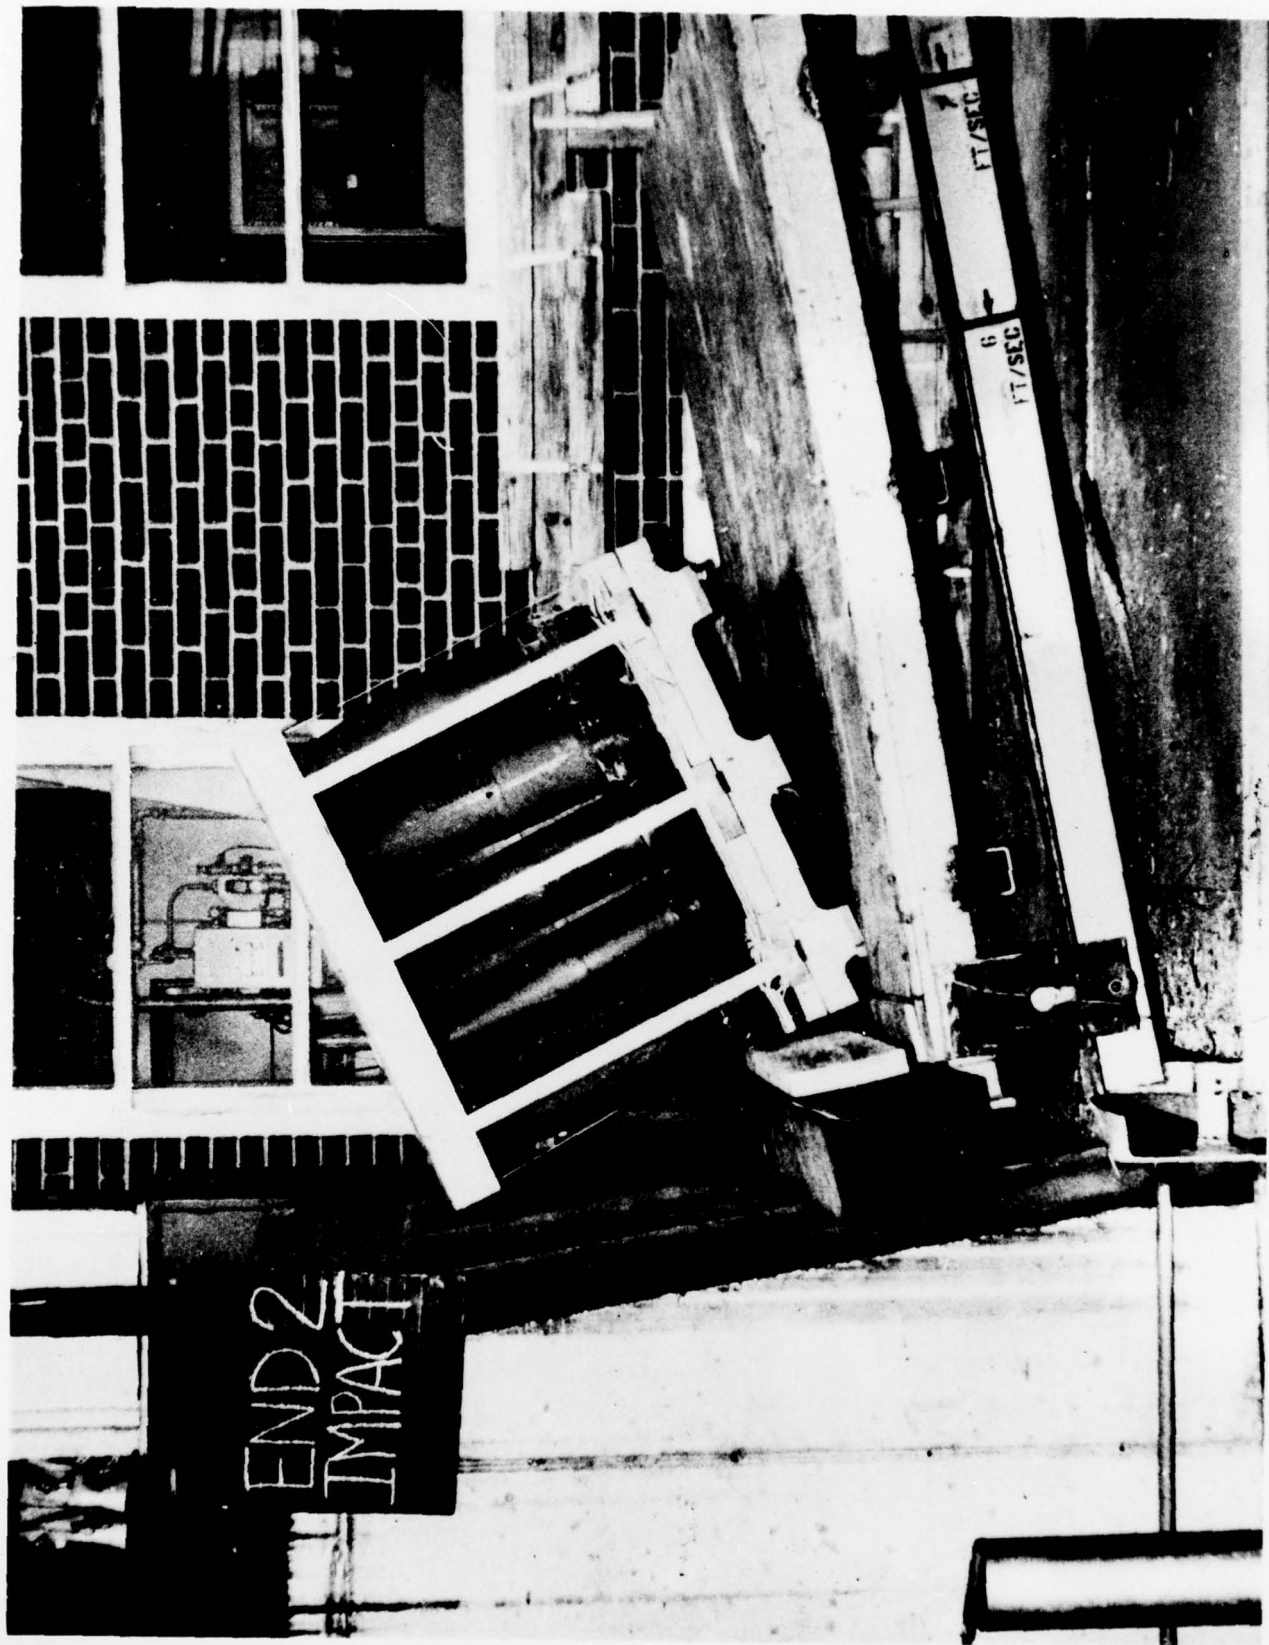
FIG. 10 ARMY 155 mm UNIT LOAD 1st END IMPACT ON 25 " SIDE

FIG. 11 ARMY 155 mm UNIT LOAD 2nd END IMPACT ON OPPOSITE 25" SIDE

The test load was placed base down on the carriage of the Conbur Impact Ramp and released from a predetermined point on the 10° track that had been calibrated to obtain an impact velocity of 10'/sec. Optional timber was used. Both ends (25" dimension) were impacted in this manner, Figures 10 and 11.

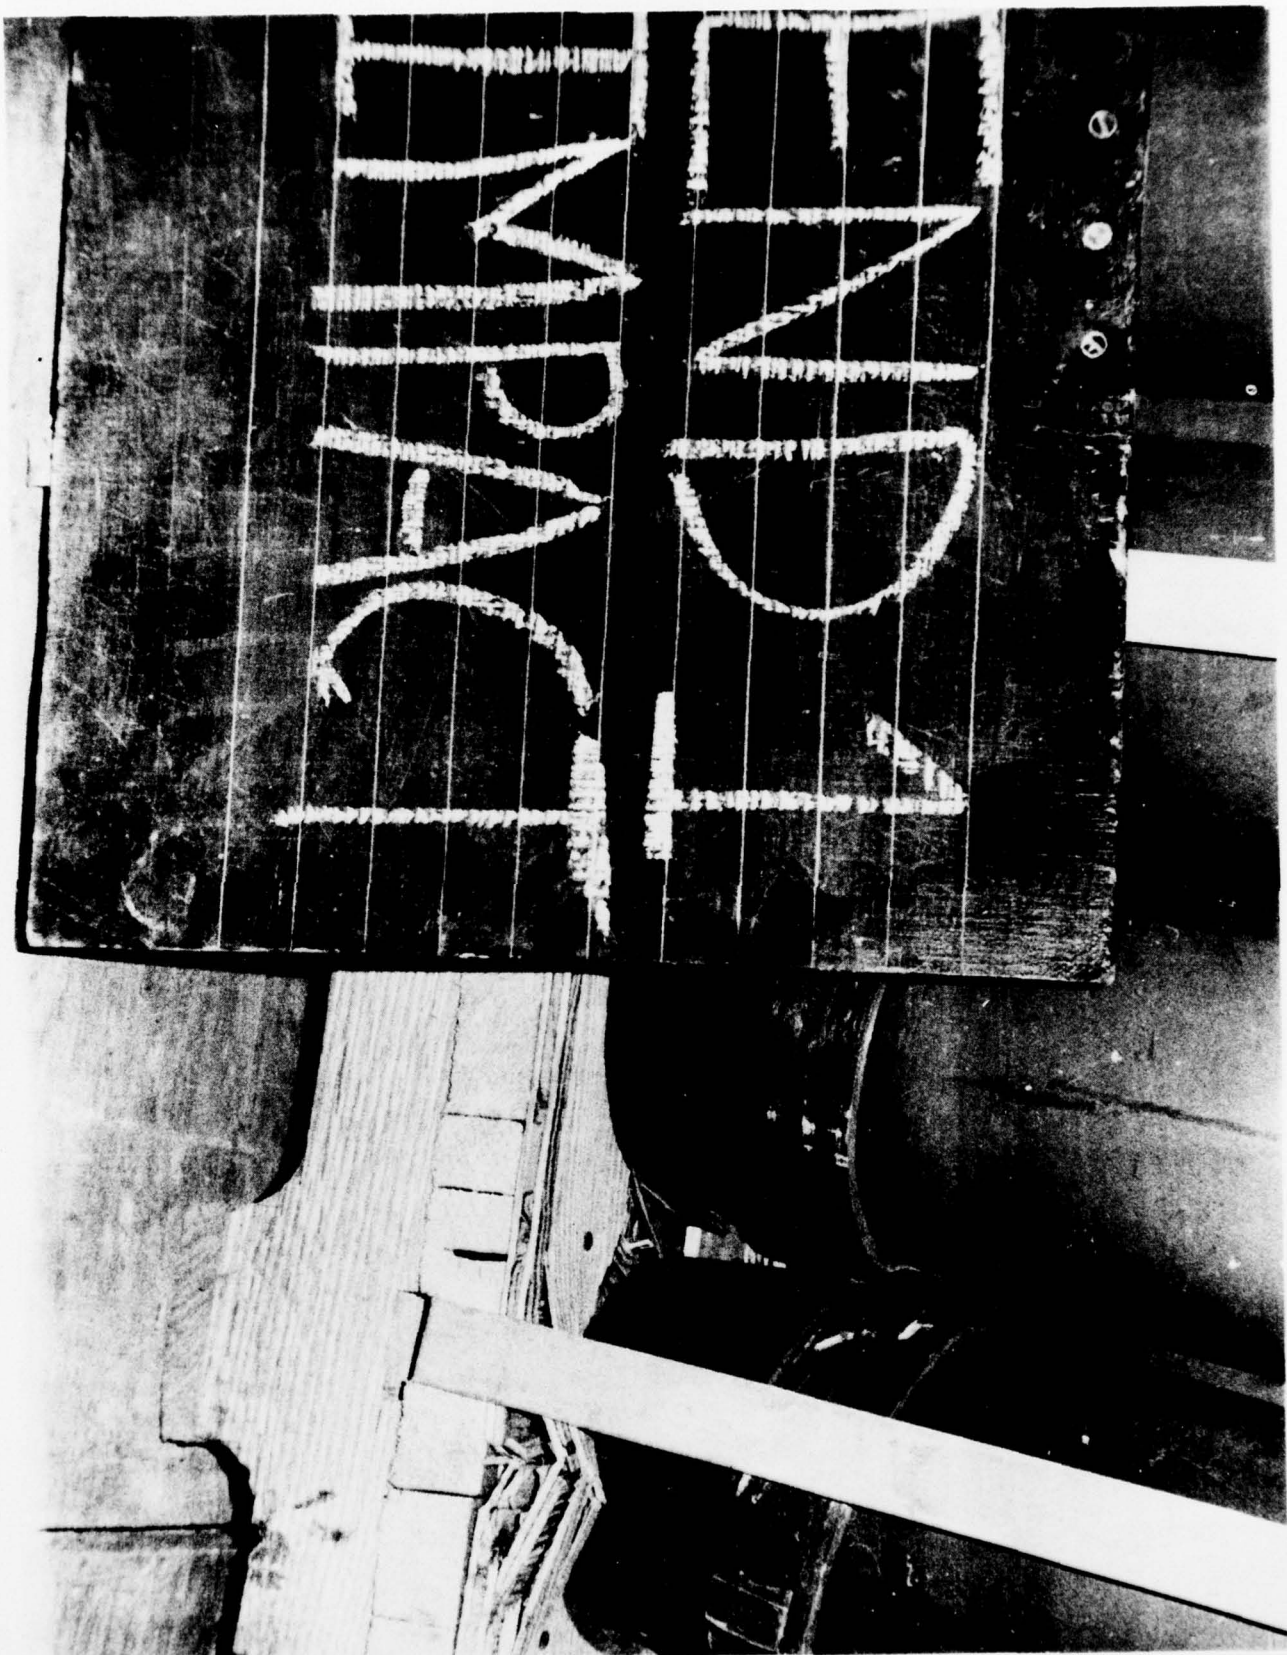
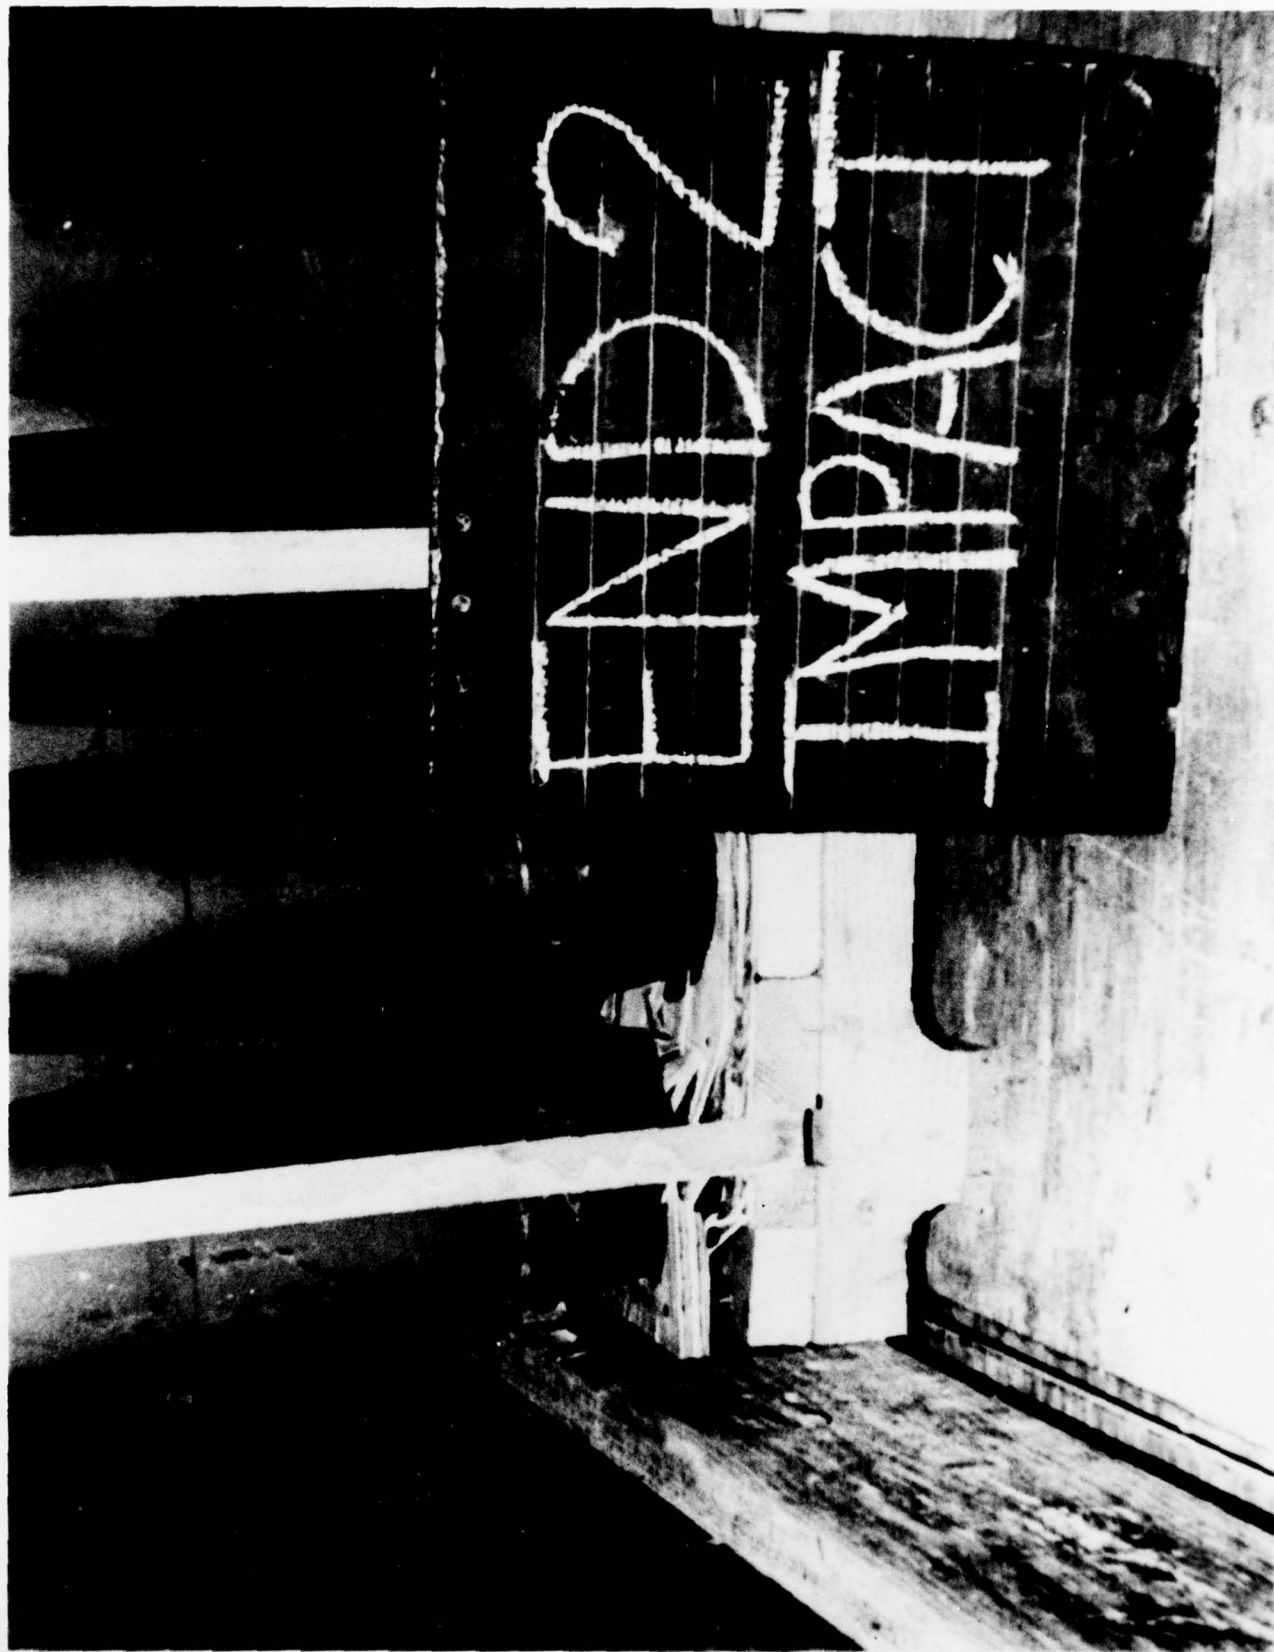
FIG. 12 mm UNIT LOAD END IMPACT BASE DAMAGE

FIG. 13 ARMY 155 mm UNIT LOAD END IMPACT NAIL WITHDRAWAL

RESULTS: On both impacts the load racked in the direction of the impact. The 3/4" plywood on the top of the pallet base cracked and splintered allowing for minimal movement of the ammunition within the unit load, Figures 12 and 13. The nails holding the 3/4" plywood to the base came loose, minimal damage was sustained to the top pallet adapter.

Based on the results from the end and side impact tests it is recommended that the unit load be made more secure with the use of pallet nails in the fabrication of the top and bottom wooden adapters and 1-1/4" (vice 3/4") plywood be utilized for the base of the bottom adapter. The use of the pallet nails and the thicker plywood would reduce the damage to the adapters in the event of impacts during handling operations. Also recommended is that by increasing both the depth of the top adapter and the diameter of the holes cut in the top adapter a more secure engagement of the projectiles will result further deterring racking/movement of the projectiles during impacts.
